Te Onewa Pa upgrade: a methodological case study in minimising effects on archaeological sites

**report to
Heritage New Zealand Pouhere Taonga
and
The New Zealand Transport Agency**

Date: 20 November 2018

Reference: 15-0623

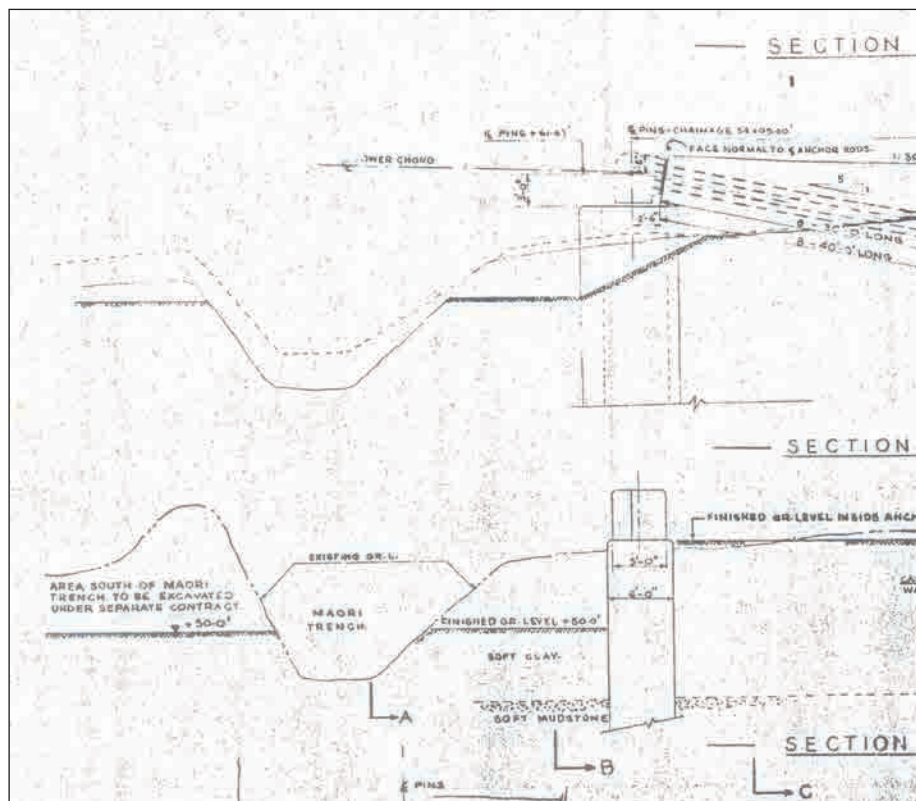
Figure 3. Detail of Drawing No. 125/1-51F by Freeman, Fox and Partners, London showing proposed cut of the pa.

The construction of the harbour bridge meant inevitable modification to Stokes Point. Records of the earthworks show that the defensive bank was to be removed, along with most of the surface, to a depth of approximately 8 feet (Figure 3). Although these plans have been sub-

mitted as part of the engineering packet at the time, it is more likely that the modification to the pa was much more limited than that.

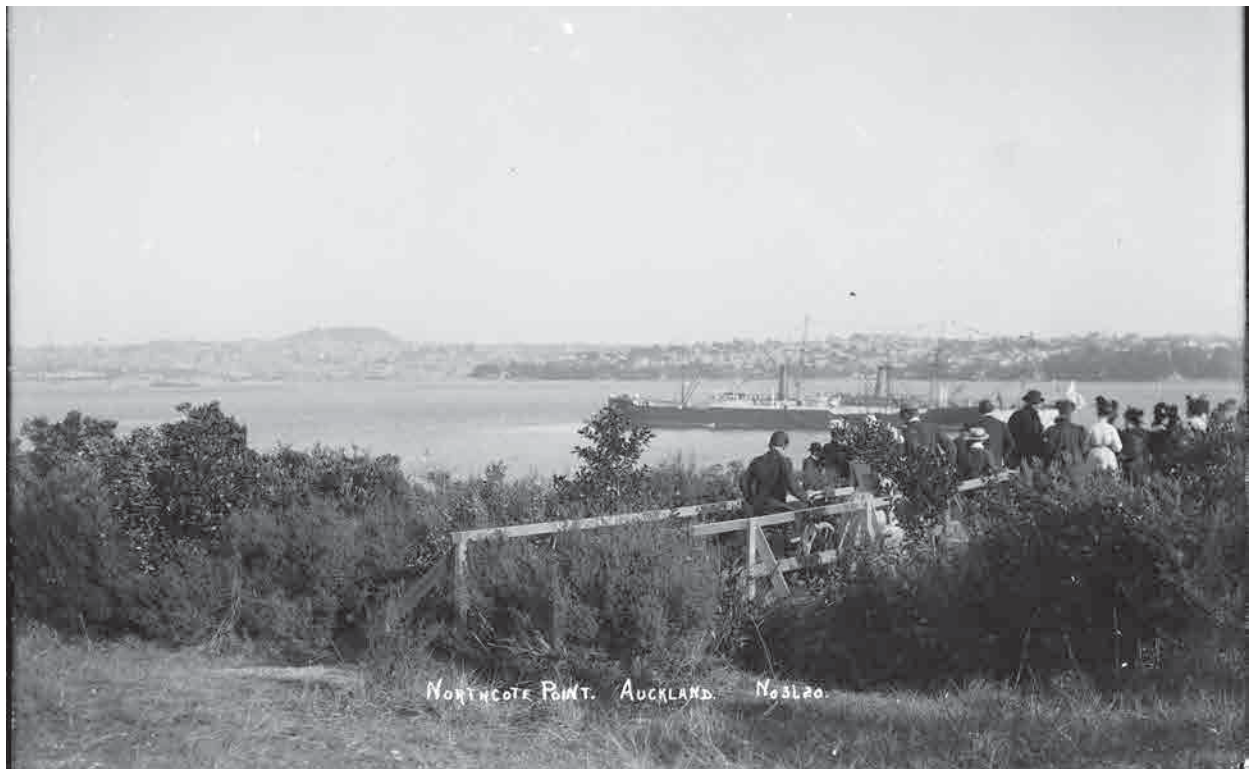
Figure 4. People crossing the footbridge over the ditch at the opening of the Northcote Domain in 1908.
Photo William A. Price, Alexander Turnbull Library 1/2-000734-G.

Photos from 1908 do not show a defensive bank as such (Figure 4) although there appears to be a gentle slope from the inside of the ditch to the south (Figure 5). Two of the flagpole stays are still in situ at ground level (Figure 6) indicating that the ground south of the ditch has not been substantially cut down. Photos from the early stages of bridge construction (Figure 7 to Figure 9) show that the undisturbed ground inside the ditch remained level and only disturbed at specific points. These pits in are most likely related to the pier visible in Figure 8, used during the construction phase. Likewise, a photo which has been tentatively dated to 1957 shows the cut for the northern abutment, in which the defensive ditch and flagpole can be seen (Figure 9).

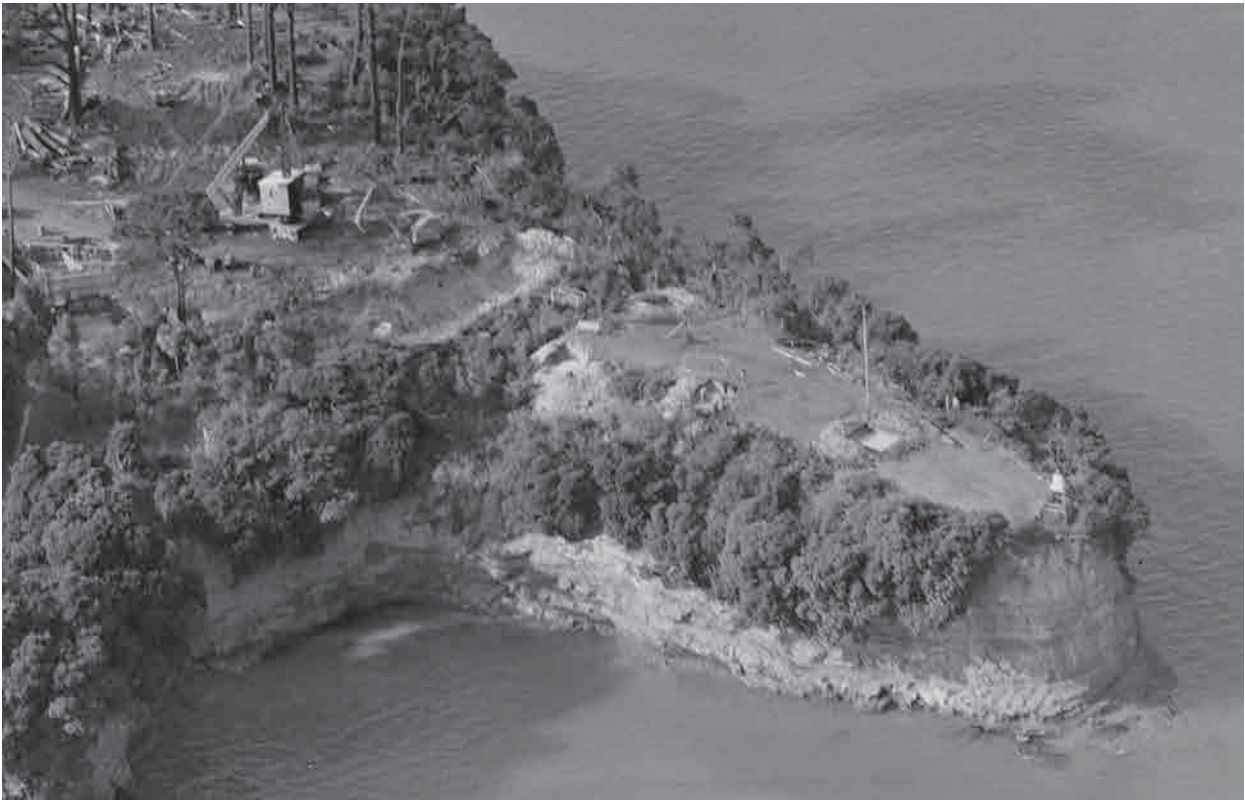
Figure 7. Detail of aerial photograph from Whites Aviation dated to 1956 showing tree felling and initial site set up. Note that the flagpole is still standing.

The first 18 holes that were drilled exposed a sandy topsoil that was generally 800 mm deep, overlying a sterile clay. In holes 12, 13, and 14, a concrete slab was encountered at 850 mm. The extent of the slab is unknown, but it is at least 2 m in length, and 500 mm thick. It is probably related to bridge construction. Between holes 53 and 57, redeposited midden and construction steel elements probably had a similar origin. This appears to be evidence of the modification to the pa from the construction of the Harbour Bridge, as they appear to line up with two of the

excavated areas in Figure 7. Elsewhere, the topsoil was between 150–200 mm deep, overlying sterile clay.

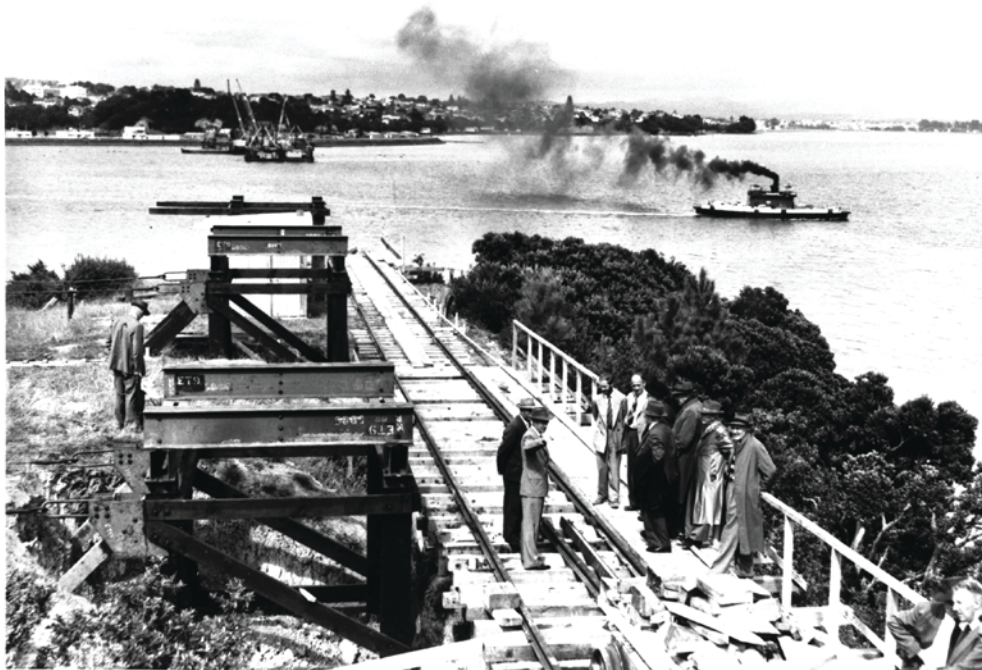
Figure 8 (above). Photo probably dated to 1957 showing the installation of a tramway along the western side of the pa. Note the pier which is being used for support, along with the stays which can be seen presumably attached to anchors to the left of frame. Sir George Grey Special Collections, Auckland Library 459-15.

It is possible that this anomaly is related to the Harbour Bridge construction, as there were at least three large holes (estimated to be 4 x 4 m) dug into the pa during construction. One of these holes roughly lines up with the anomaly (Figure 8), but it should be noted that the other large hole in front of the flagpole was not picked up by the resistivity survey.

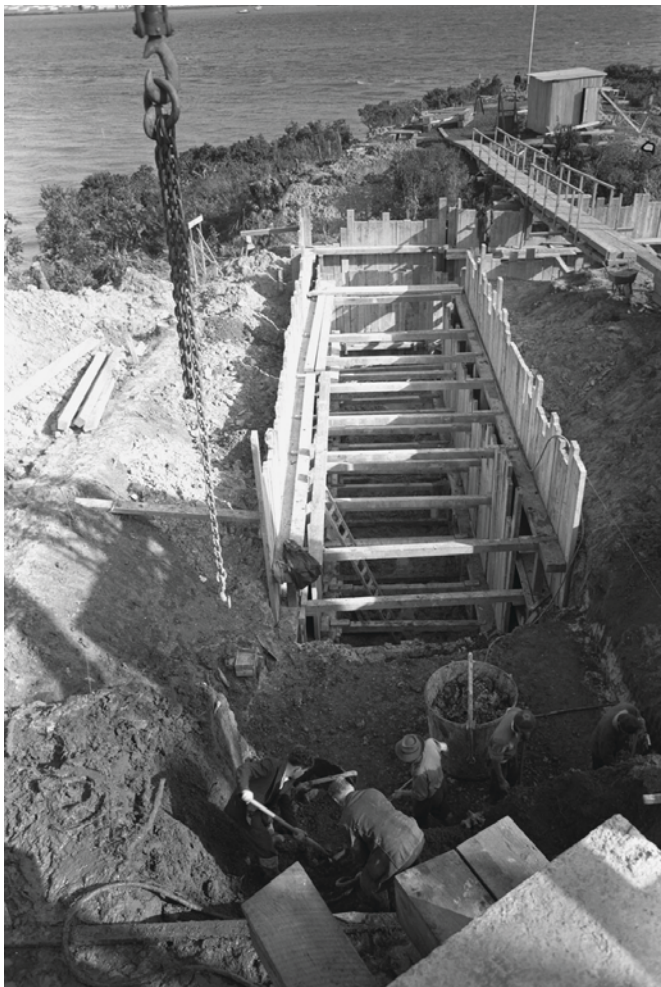
Figure 9 (left). Photo probably dated to 1957 showing construction of northern anchorage. note the surface height, and flagpole still in place. Sir George Grey Special Collections, Auckland Library 314-A16365.

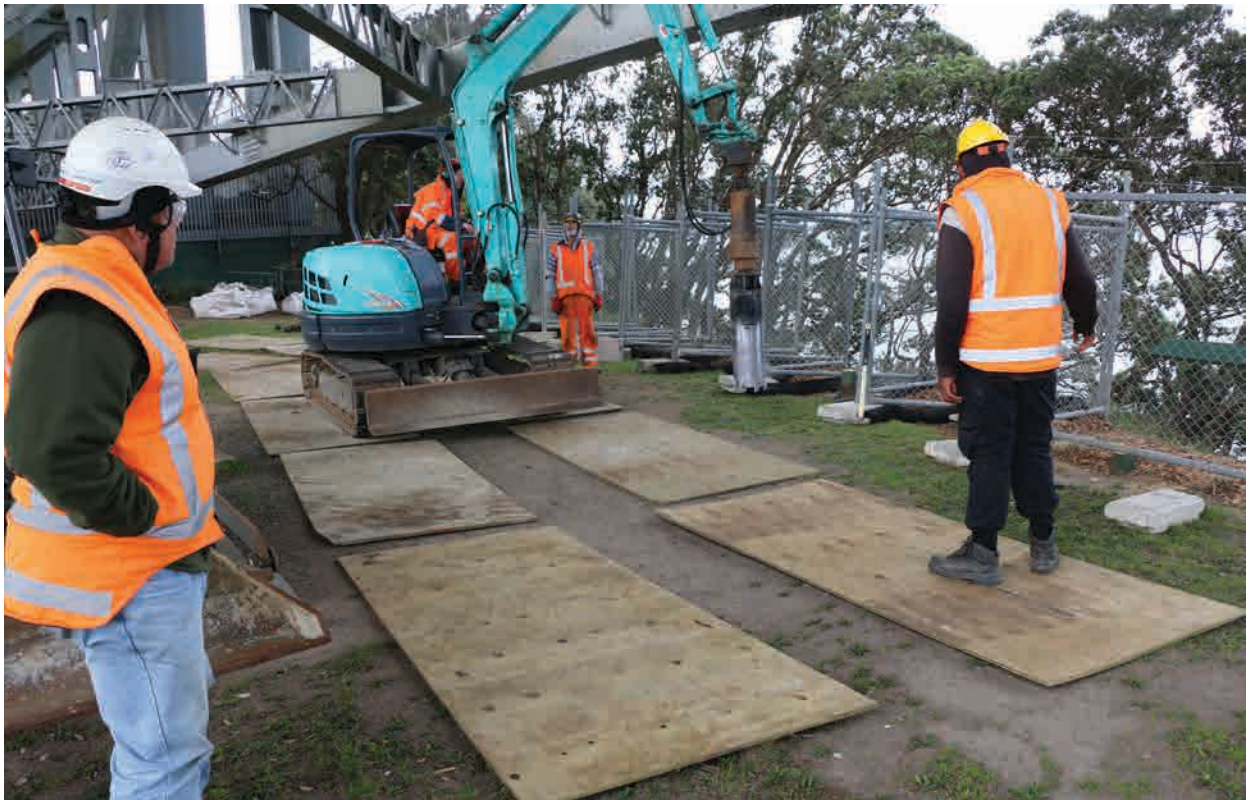
Figure 12. Plywood sheeting being used to mitigate ground disturbance by heavy machinery.

All ground disturbance was monitored by an archaeologist. On the western side of the bridge abutment, geotechnical cloth was laid, and basecourse was placed over the surface so that the high vehicle traffic did not adversely impact the ground surface. All machinery movement within the extent of the pa was undertaken on top of 17 mm ply sheets to ensure no ground disturbance was caused by vehicle tracks or wheels.

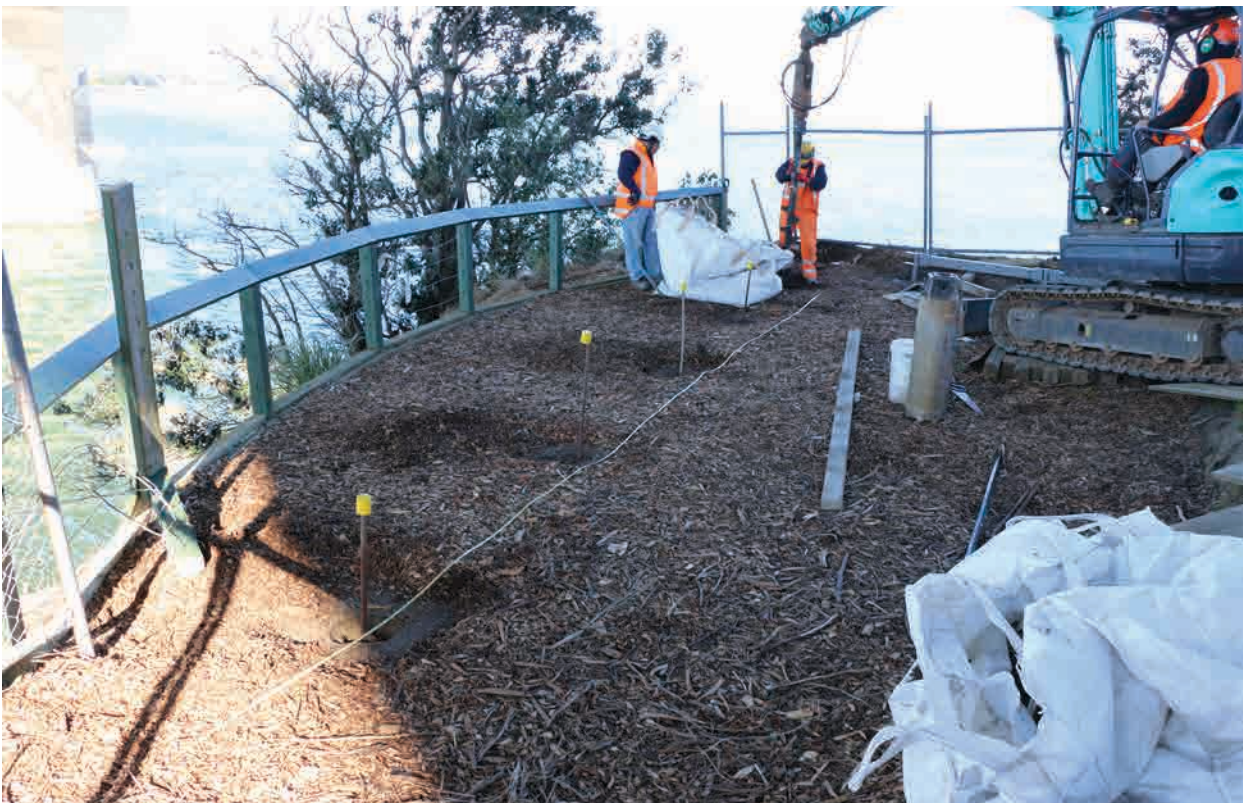
Figure 15. View south of new fence post footings being augured.

Starting from the eastern side and working clockwise about the reserve, the existing fence posts were cut down leaving approximately 250 mm exposed above the ground. The topsoil was then removed around the post to expose the concrete footing. A bolt was placed at the centre of the post and a guide jig was used to align the 310 mm coring auger. The post was then cored and lifted out. The hole was inspected and extended using a 280 mm auger to a final depth of 1300 mm to accommodate the new post.

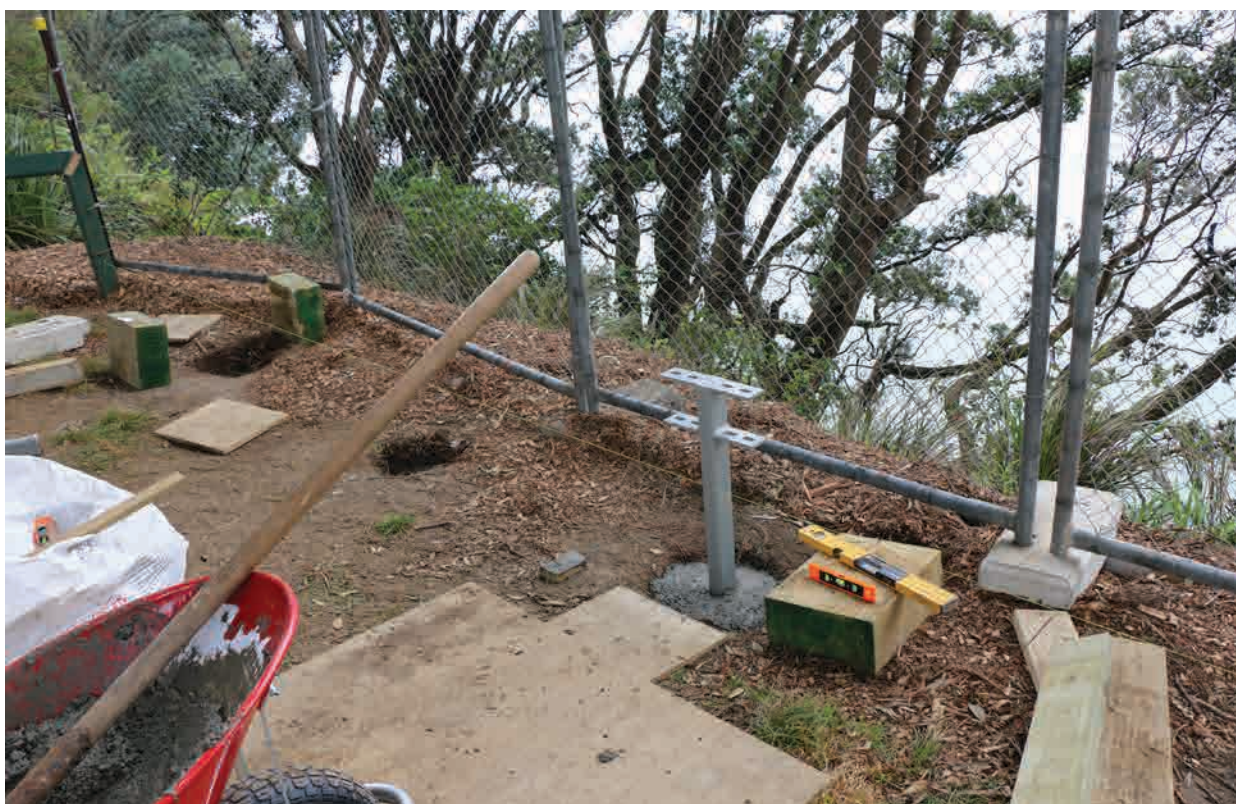
Figure 16. New fence post in place.

Extracting each post and footing as a single unit would cause a significant ground disturbance to the pa, affecting not only any potential archaeological features below the surface but also the bank stability. To ensure the works were in keeping with the concept of minimal disturbance, a methodology was devised to reutilise the current concrete footings by using a concrete coring auger to remove the existing posts and creating a hole for the new steel post and concrete to be poured into.

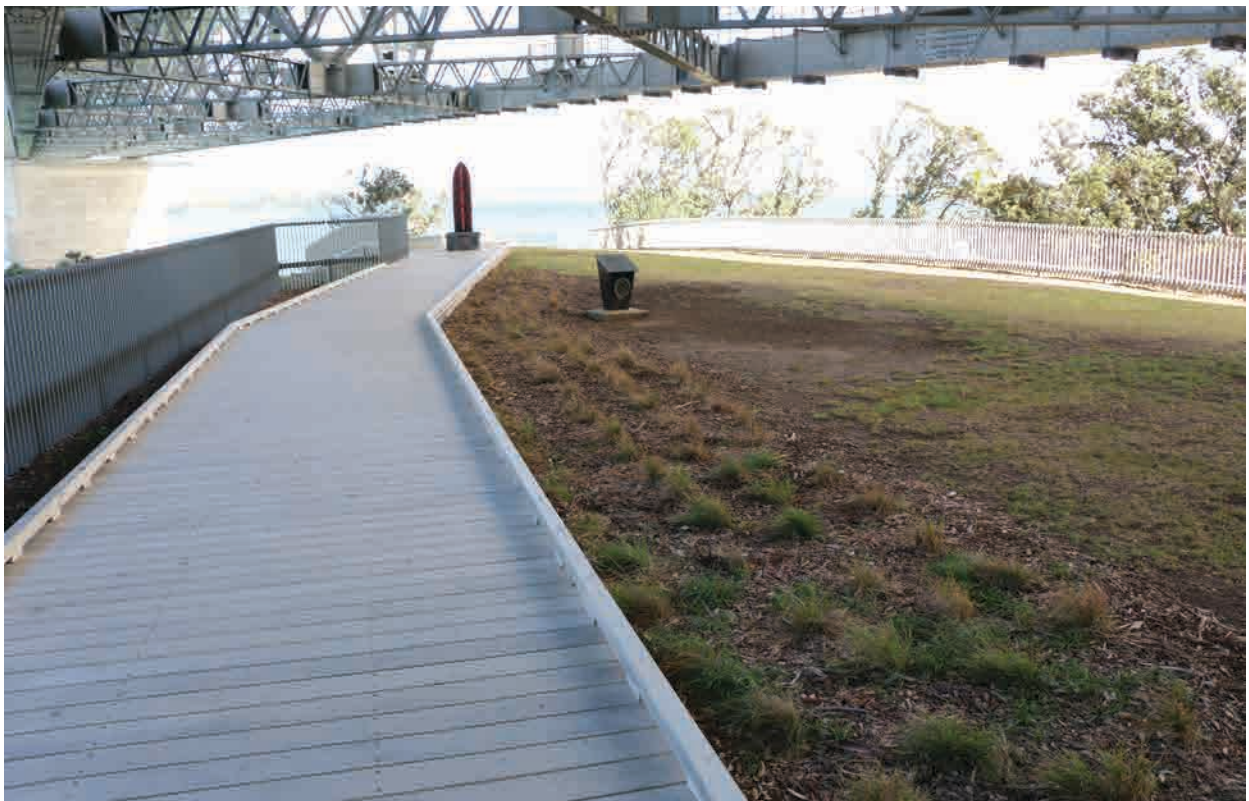
Figure 19. View down boardwalk showing new planting.
